## Structural Condition Assessment at Royal Centre IV (2010)

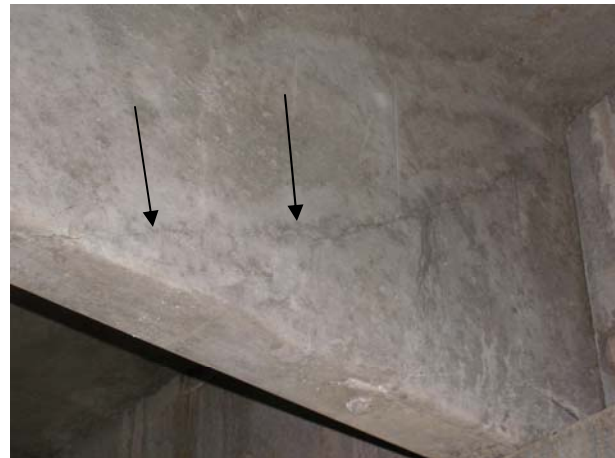
Significant cracks and spalled areas were noted in several double tee beam stems, inverted tees, and L beams. Recommended repairs to these areas included epoxy injection of cracks greater than .016 inches, removing distressed concrete, cleaning any exposed reinforcing steel, and patching with an appropriate repair material. The crack in photo above was recommended for epoxy injection repair.

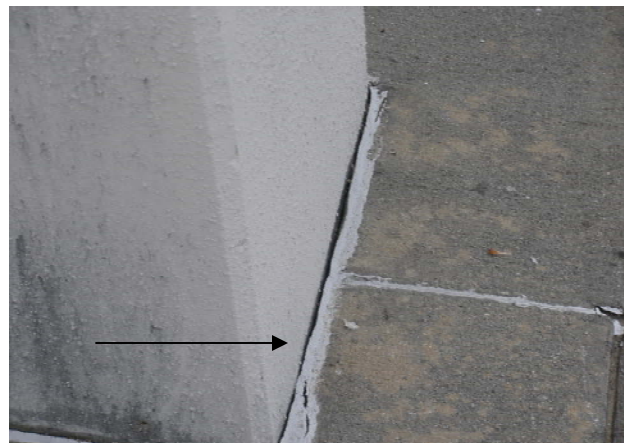
Cove Sealants around columns and perimeter pour strip sealants were missing in much of the parking deck. Cove sealants are recommended at the interface of vertical to horizontal elements to protect from rain runoff infiltration into cracks associated with these interfaces. Existing sealant joints throughout the parking deck were observed to be approaching the end of their service life. They were recommended to be removed and replaced. The photo above is an example of a cove sealant that was not missing but has reached the end of its service life.
